Situation Photo Log

Friday, October 12, 2012

Kalamazoo River / Enbridge Spill

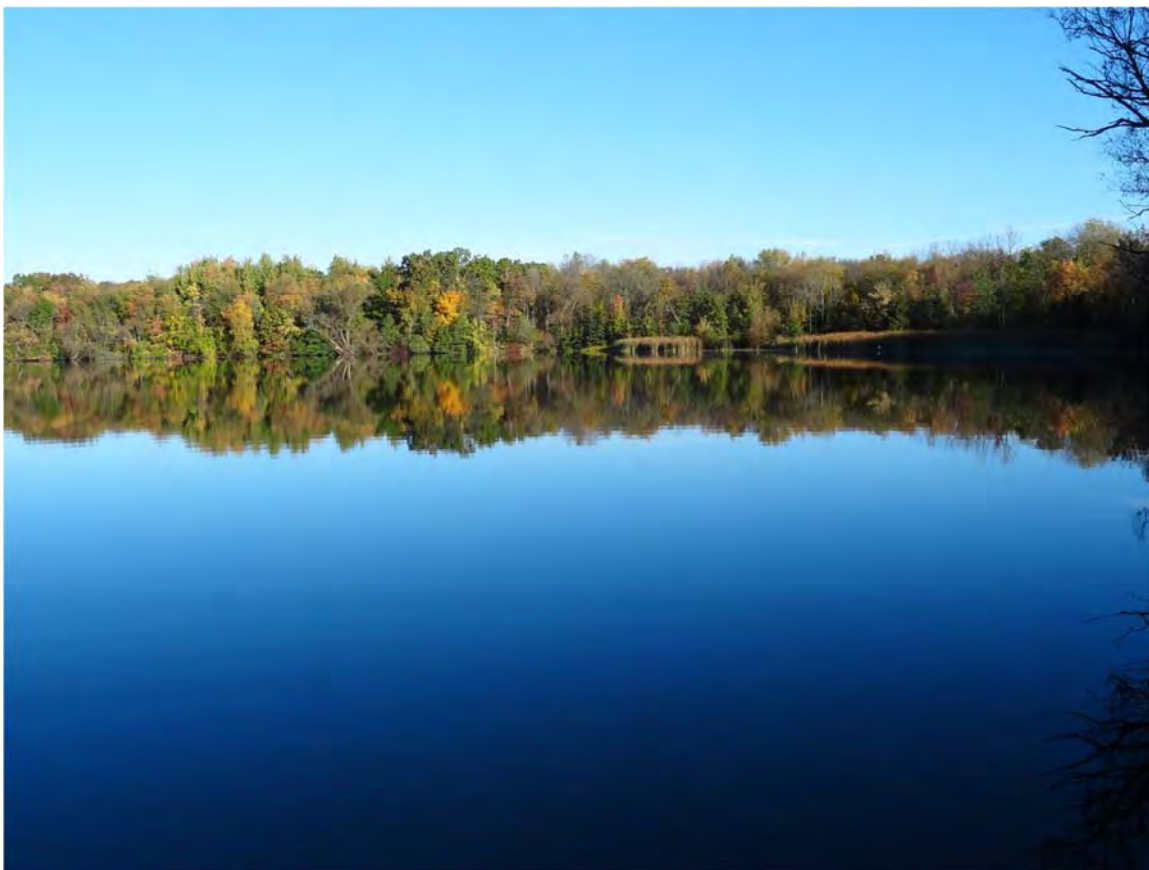
1. Morrow Lake north cove no sheen observed.

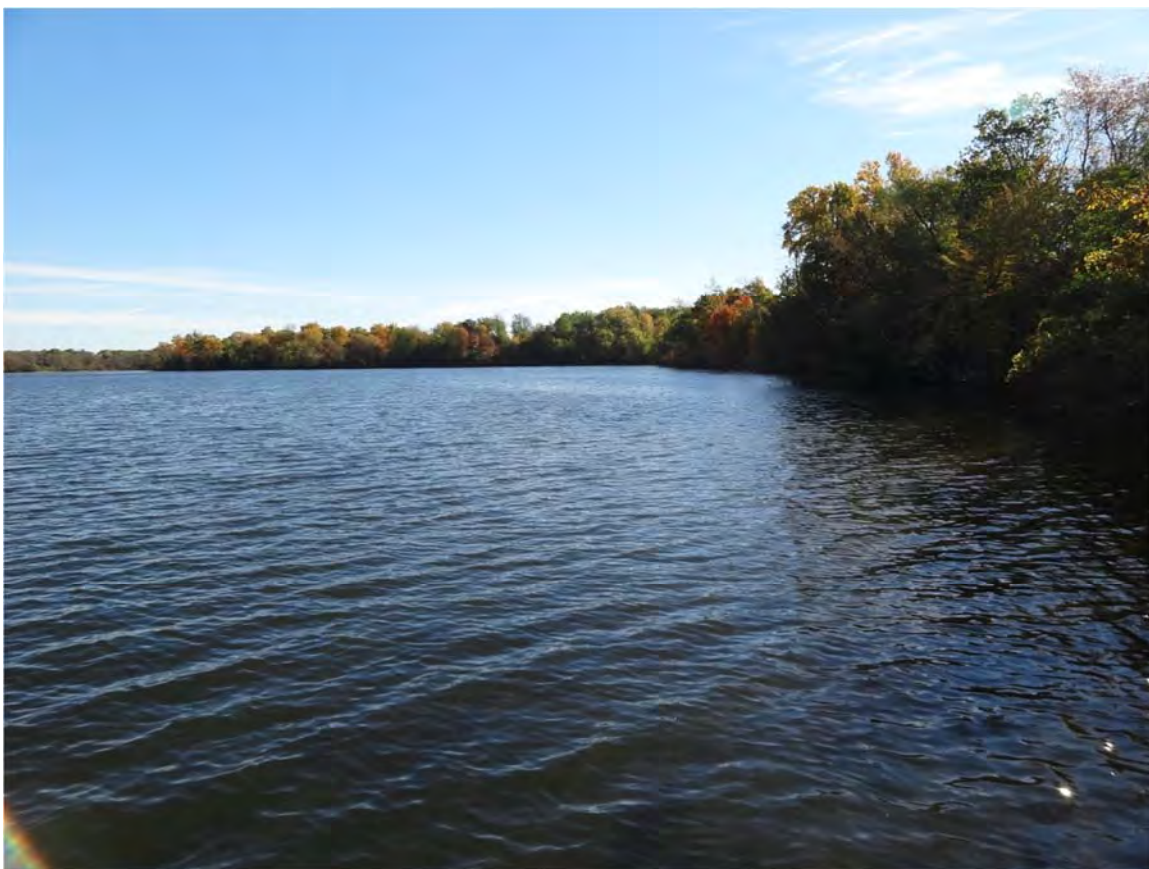
2. Morrow Lake south cove no sheen observed.

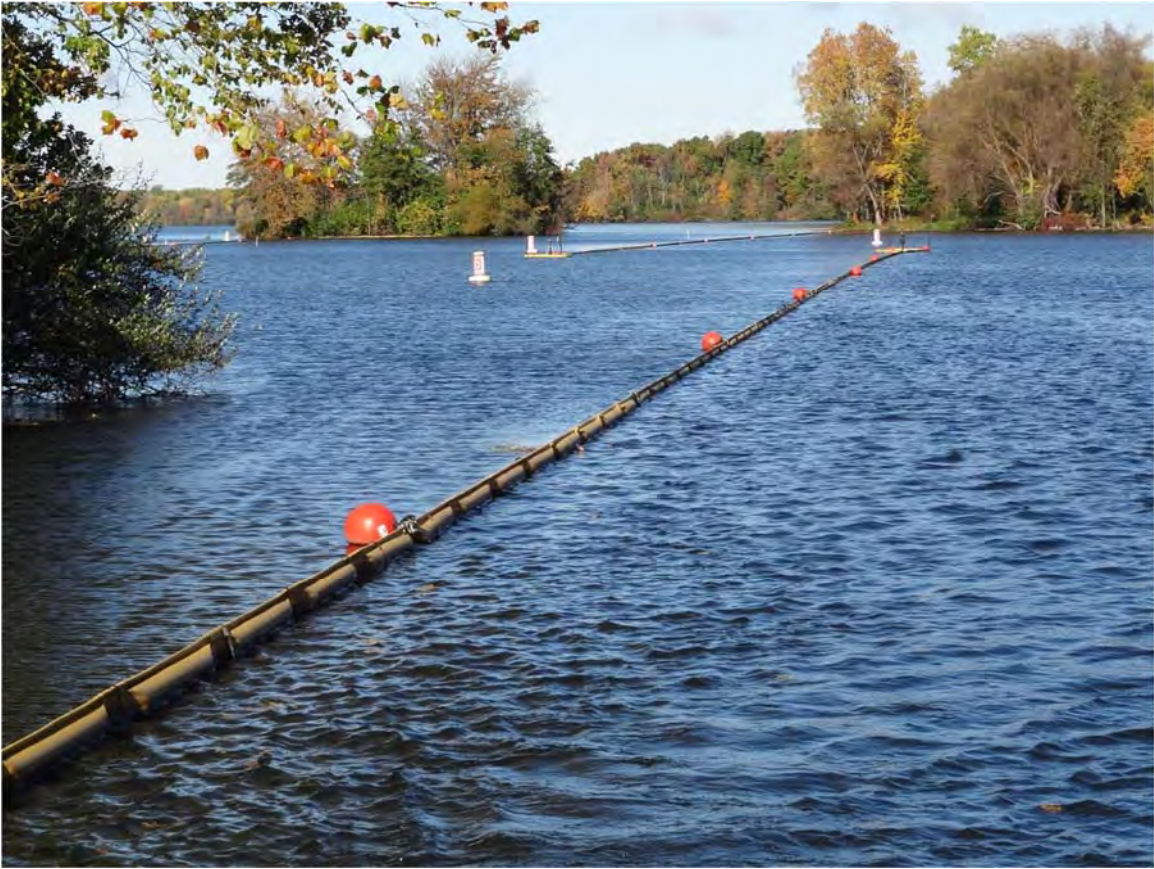
3. Morrow Lake Delta Gate E no sheen observed.

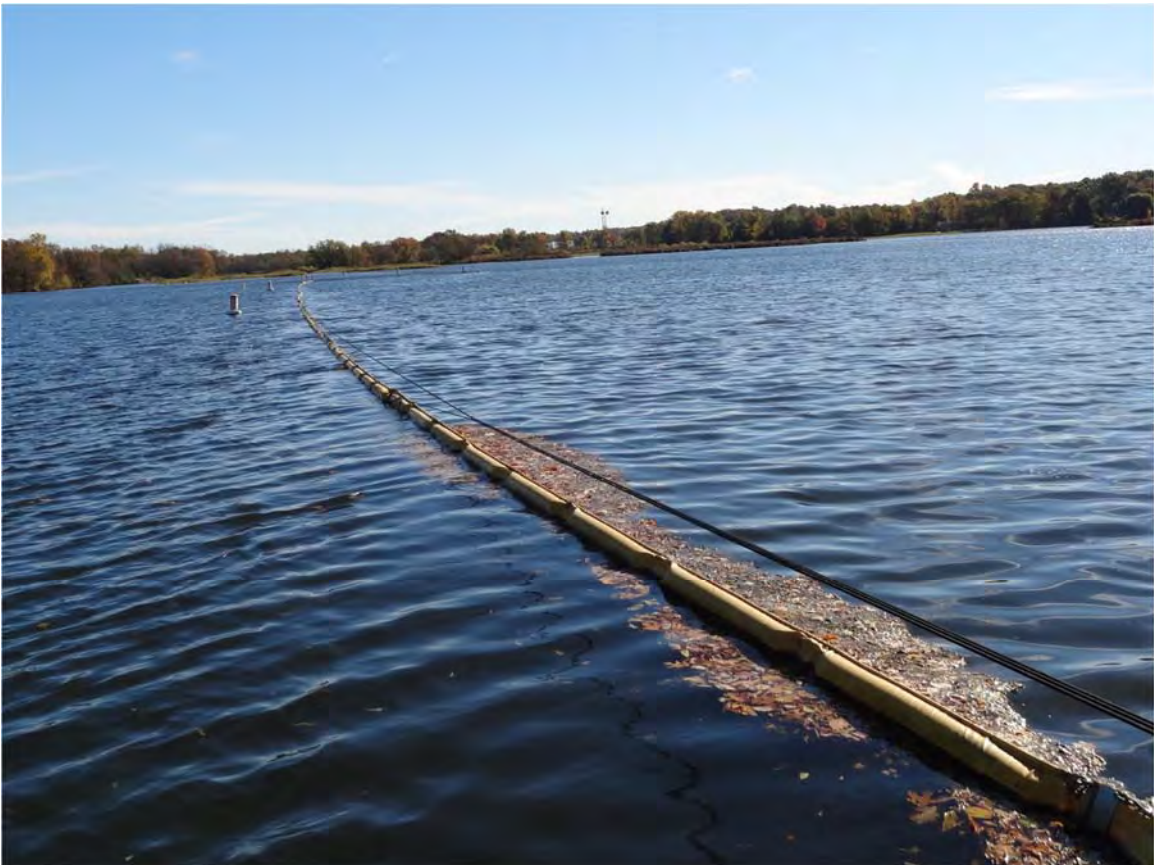
4. Morrow Lake Delta Gate C no sheen observed.

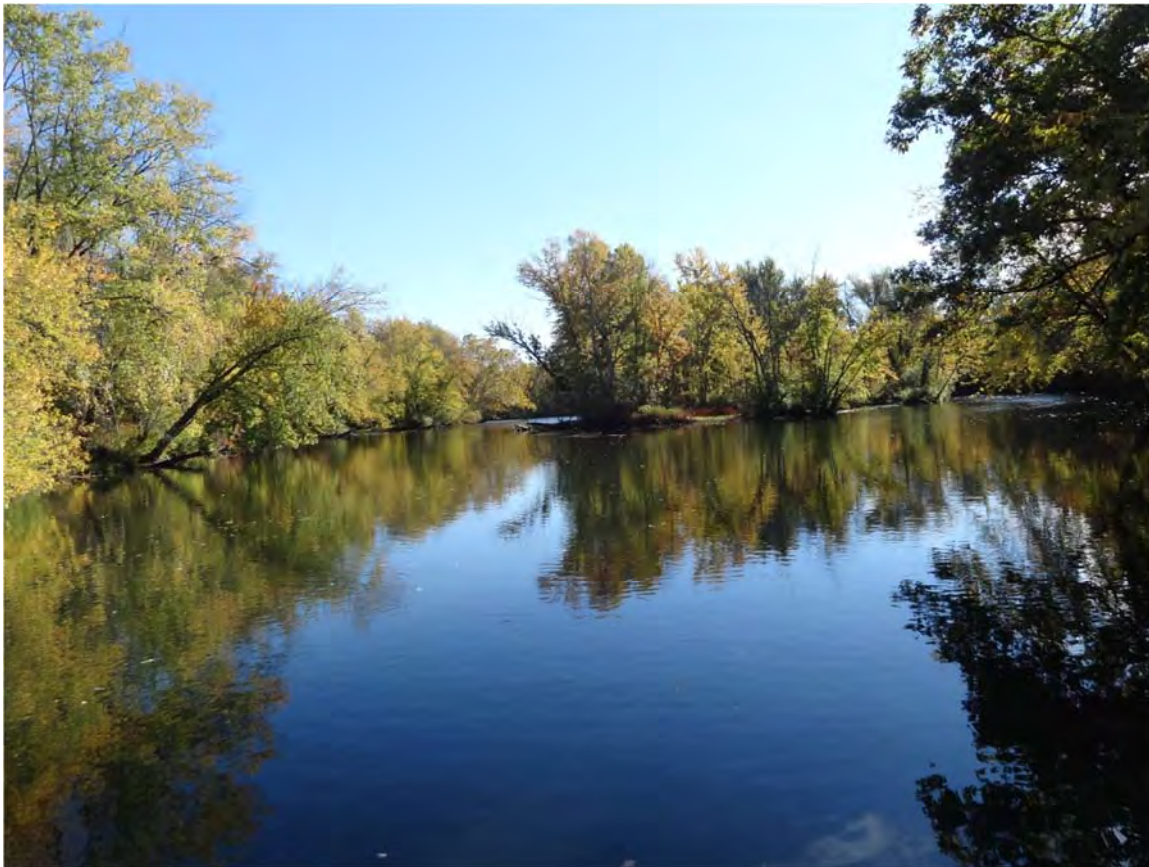
5. MP36.25 Island no sheen observed.

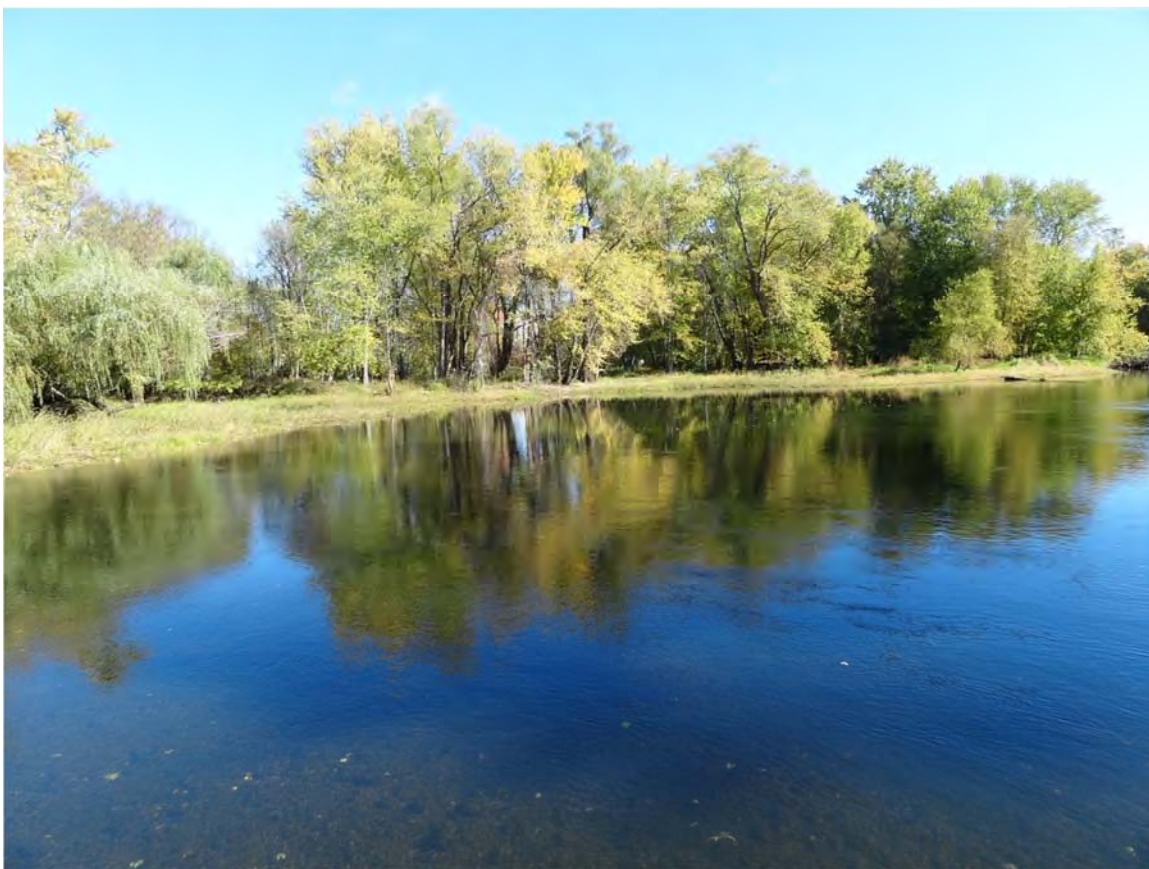
6. MP26.25 RDB no sheen observed.

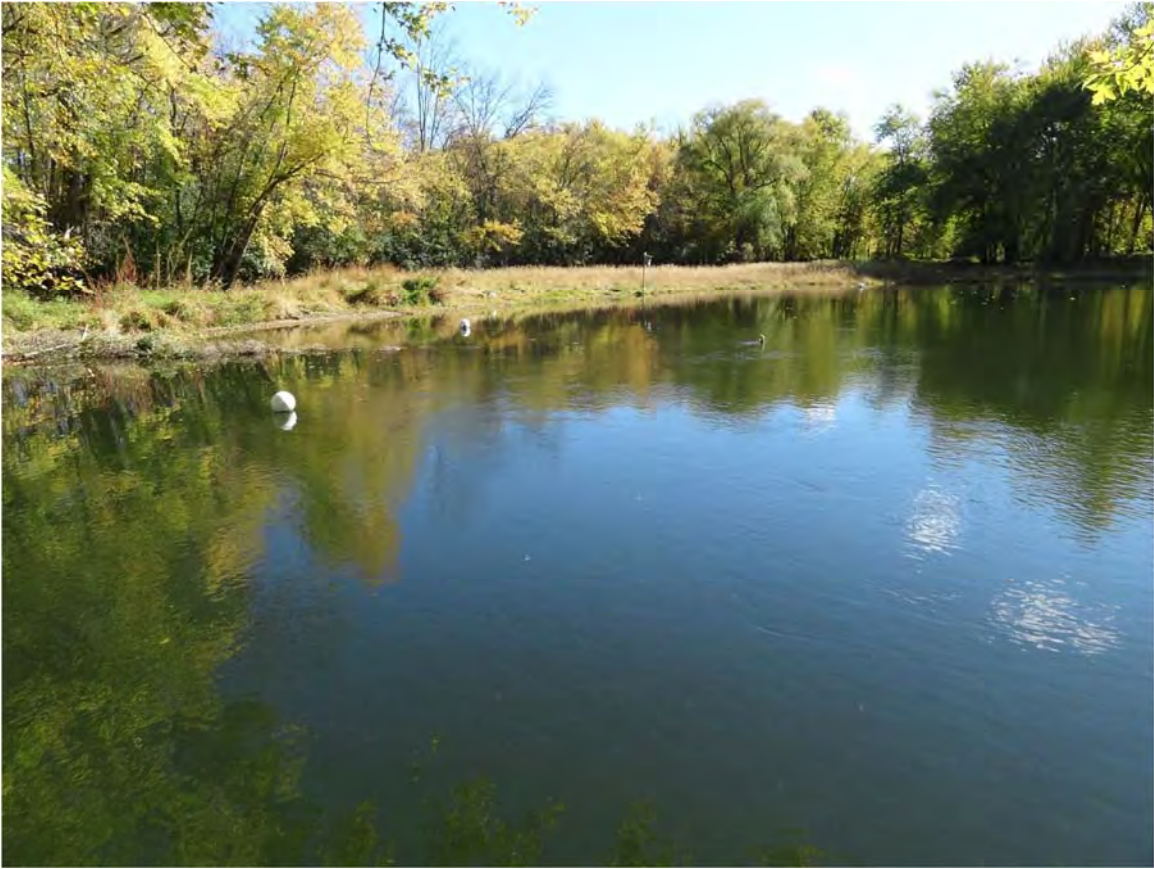
7. MP26.0 RDB Sediment trap no sheen observed.

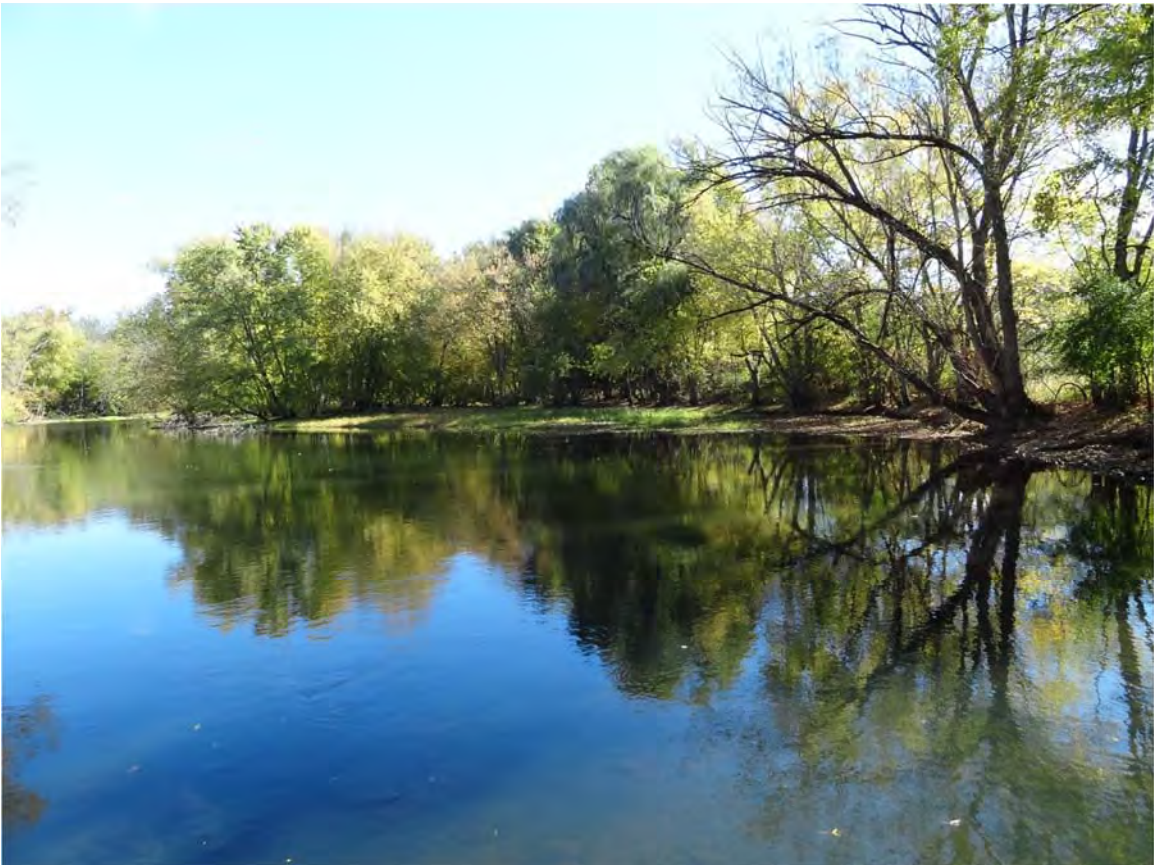
8. MP24.75 no sheen was observed.

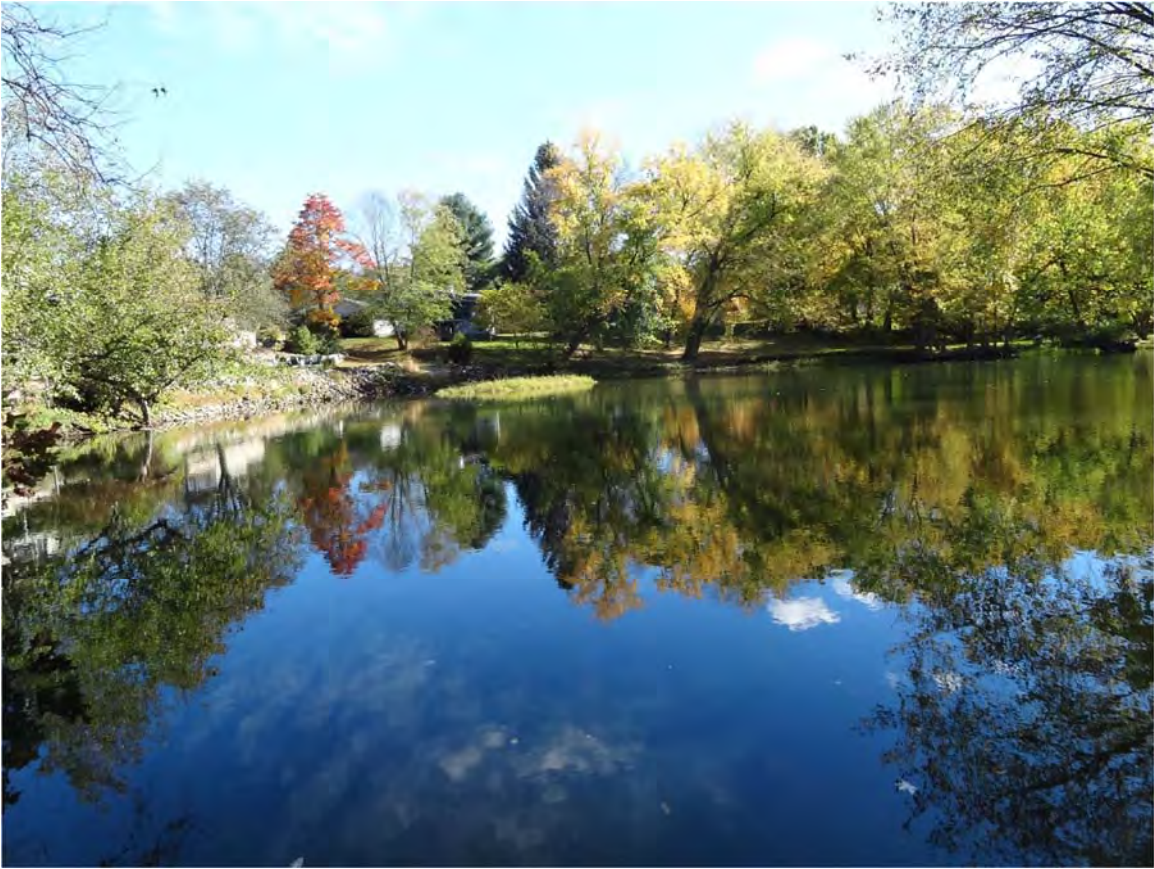
9. MP23.1 RDB no sheen observed.

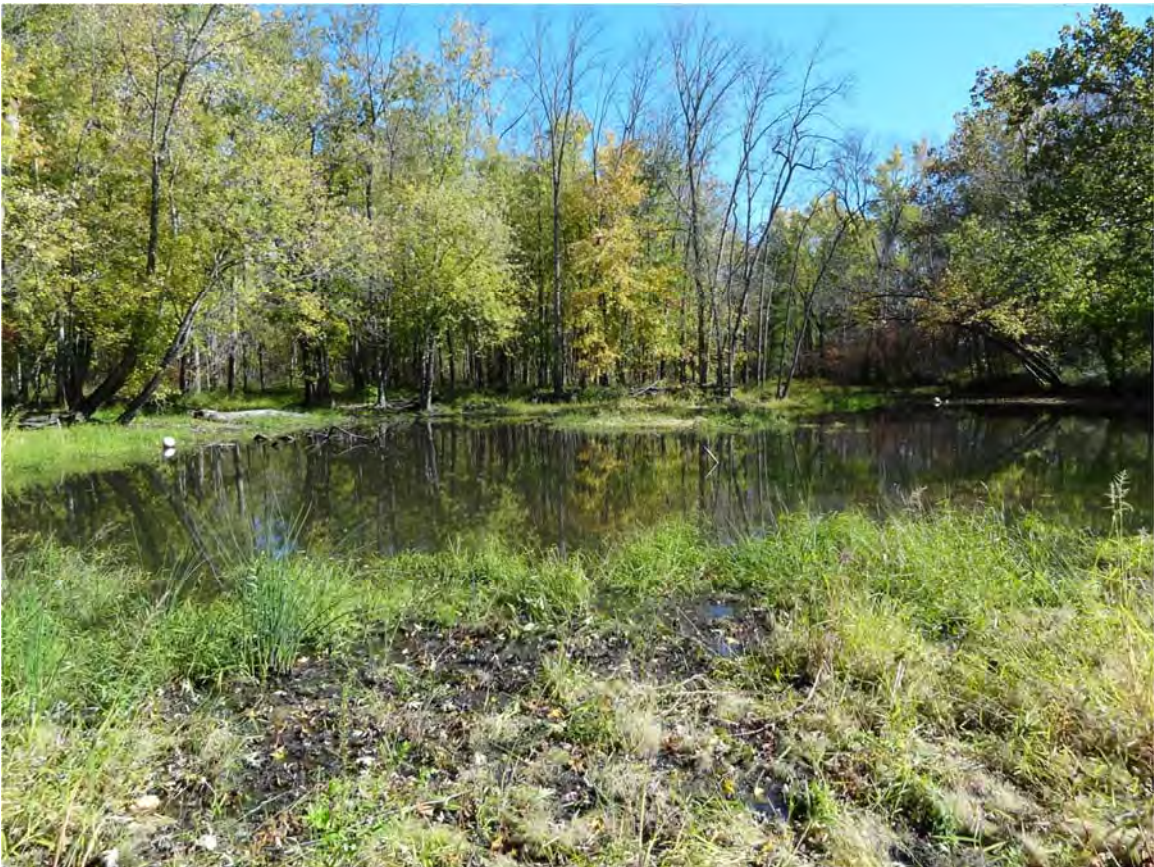
10. MP30.8 Sediment Trap no sheen observed.

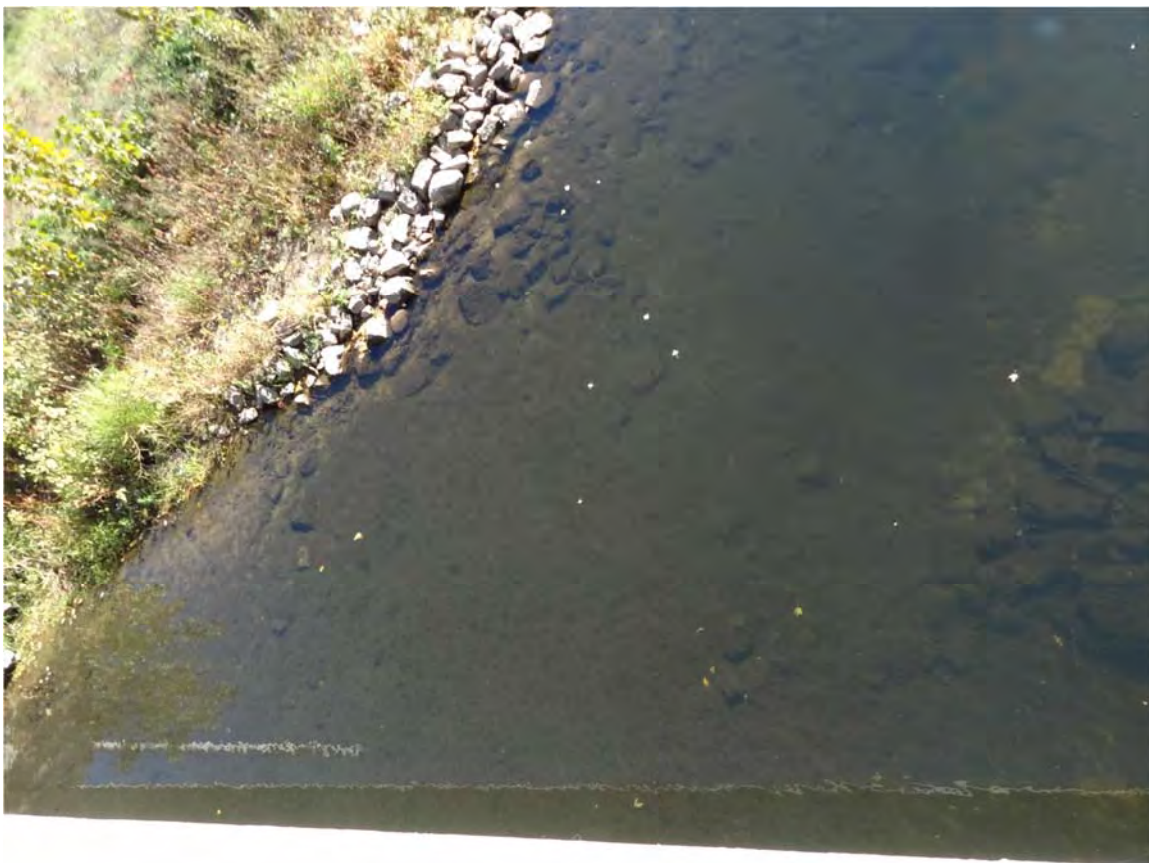
11. MP21.5 Custer Drive bridge no sheen observed.

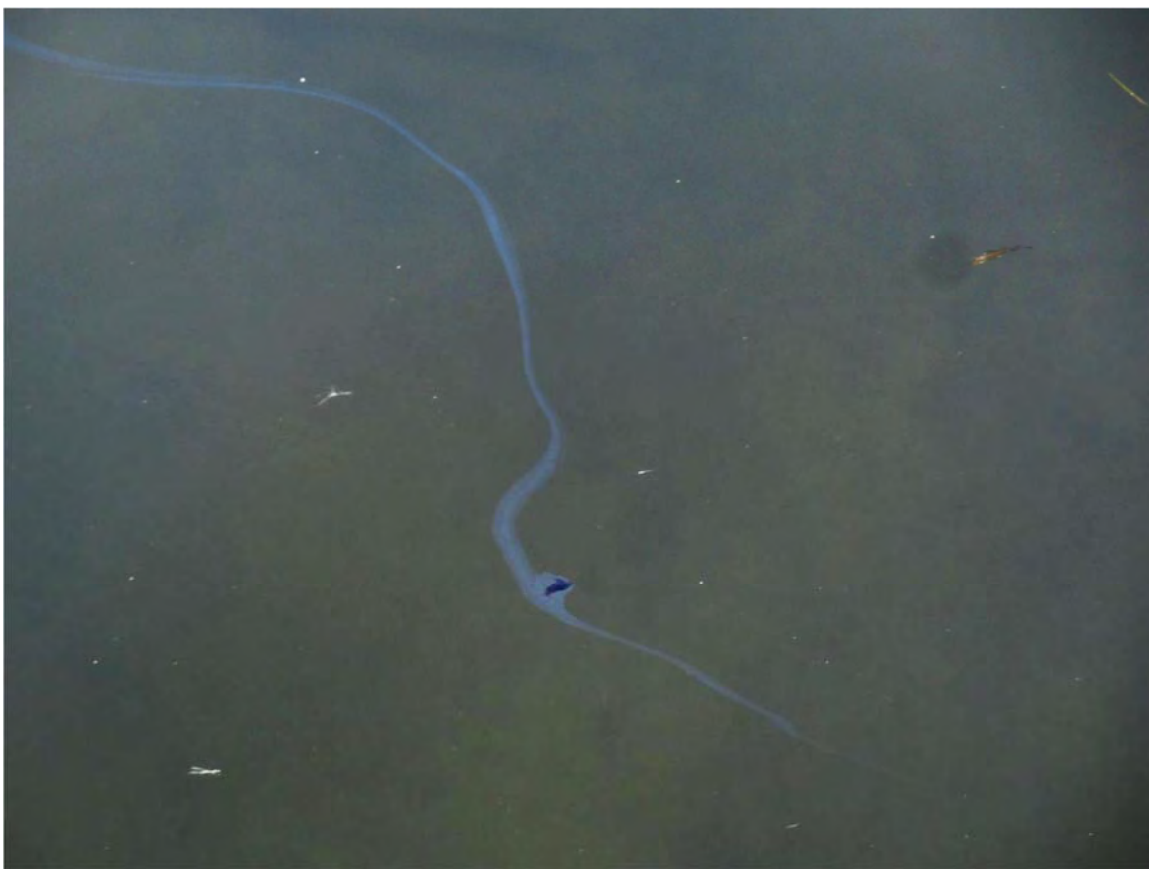
12. MP5.45 LDB spontaneous sheen and tar glob observed.

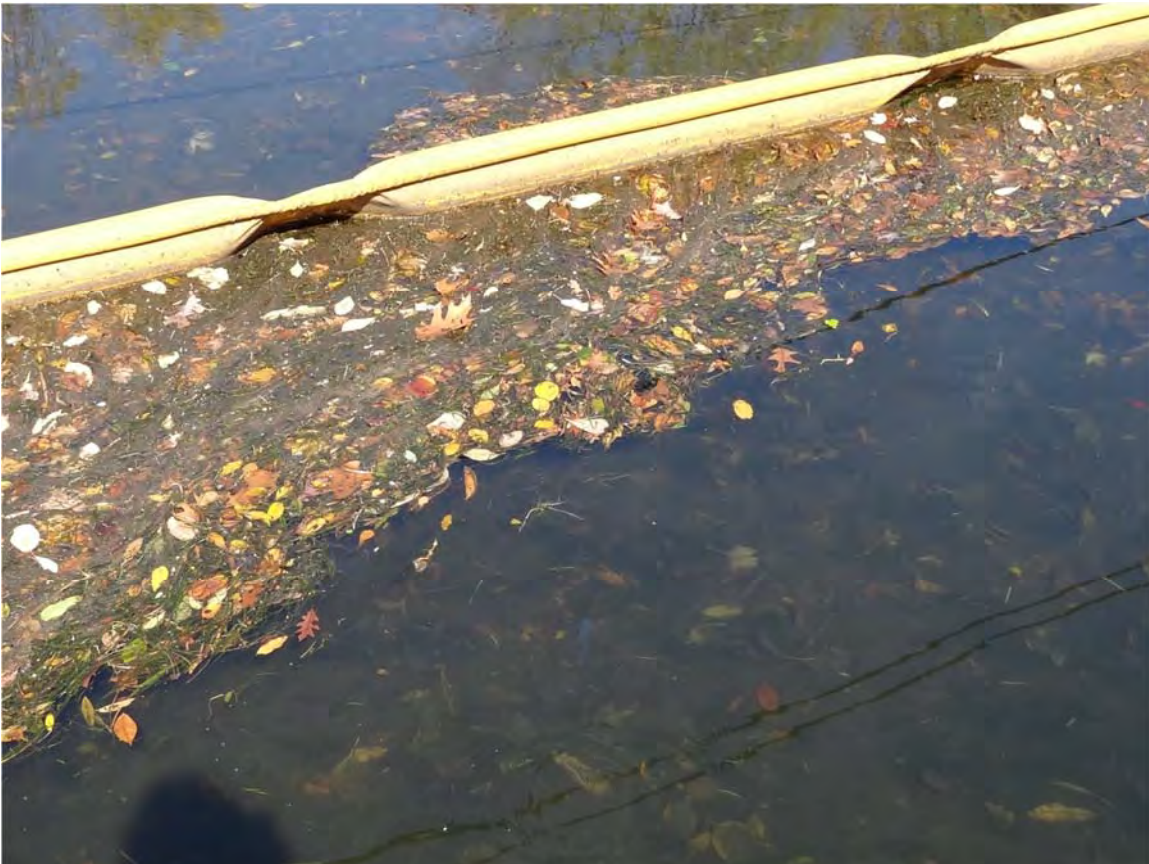
14. Sheen observed collecting along the Ceresco Dam control point boom.
